FLIGHT MEASUREMENTS OF THE FLYING QUALITIES

OF AN F6F-3 AIRPLANE (BUAER NO. 04776)

II - LATERAL AND DIRECTIONAL STABILITY AND CONTROL

By Walter C. Williams and John P. Reeder

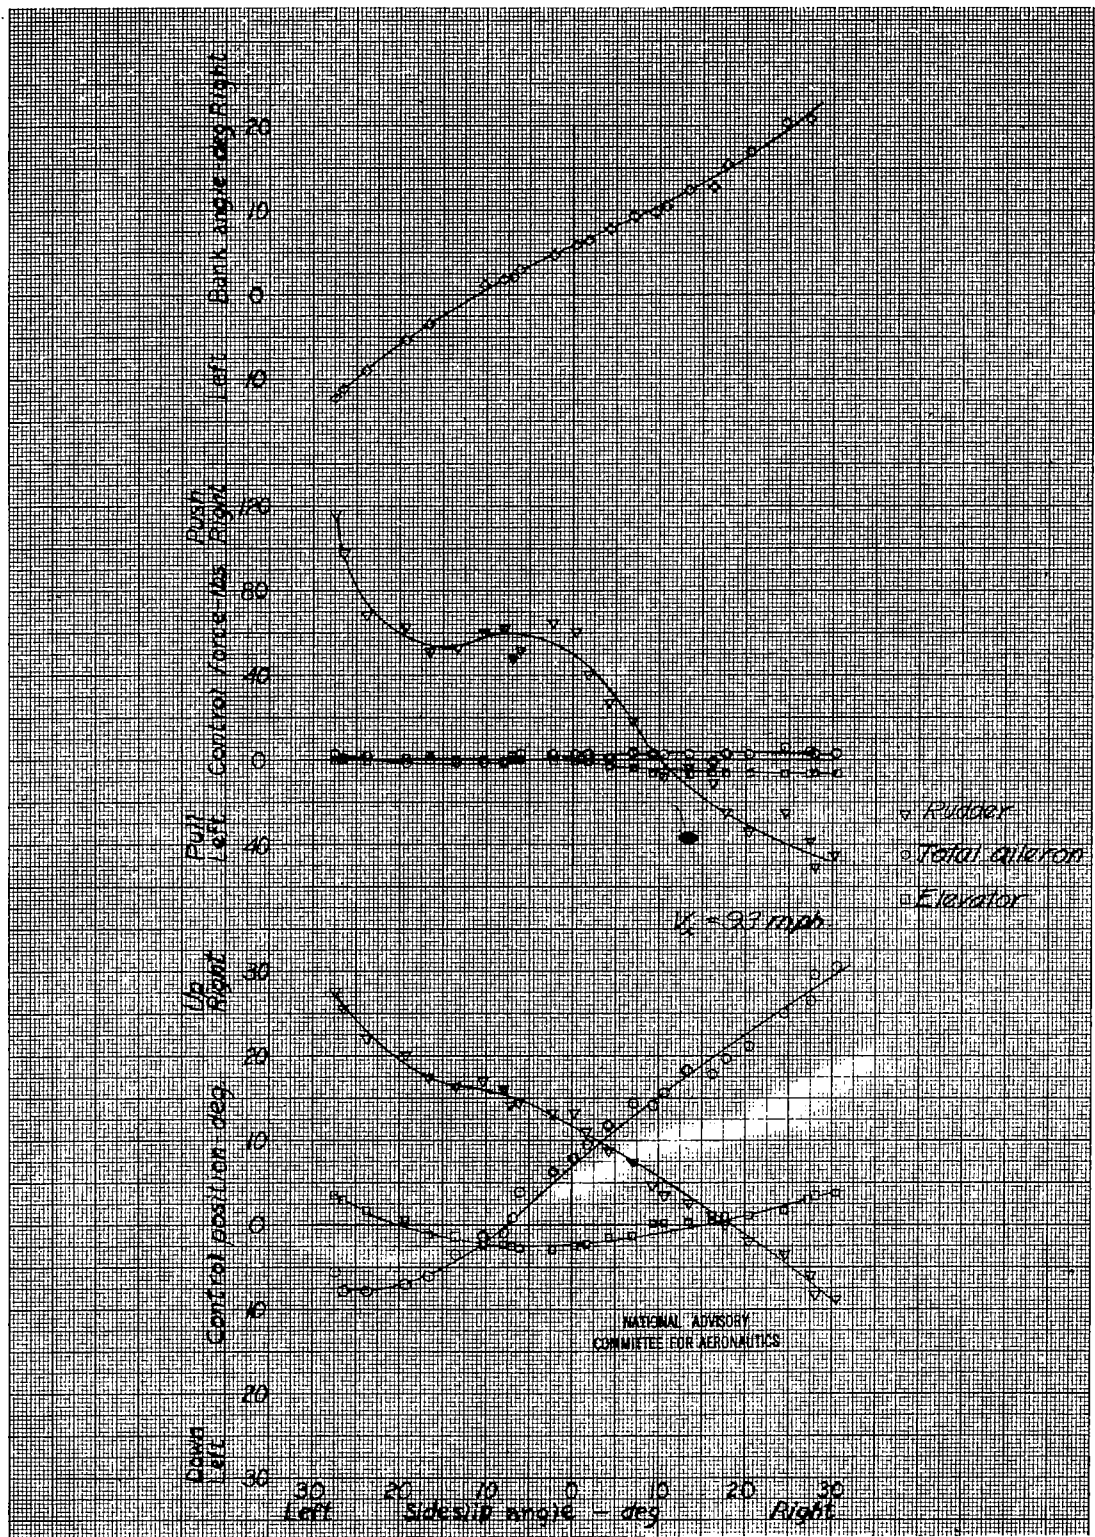
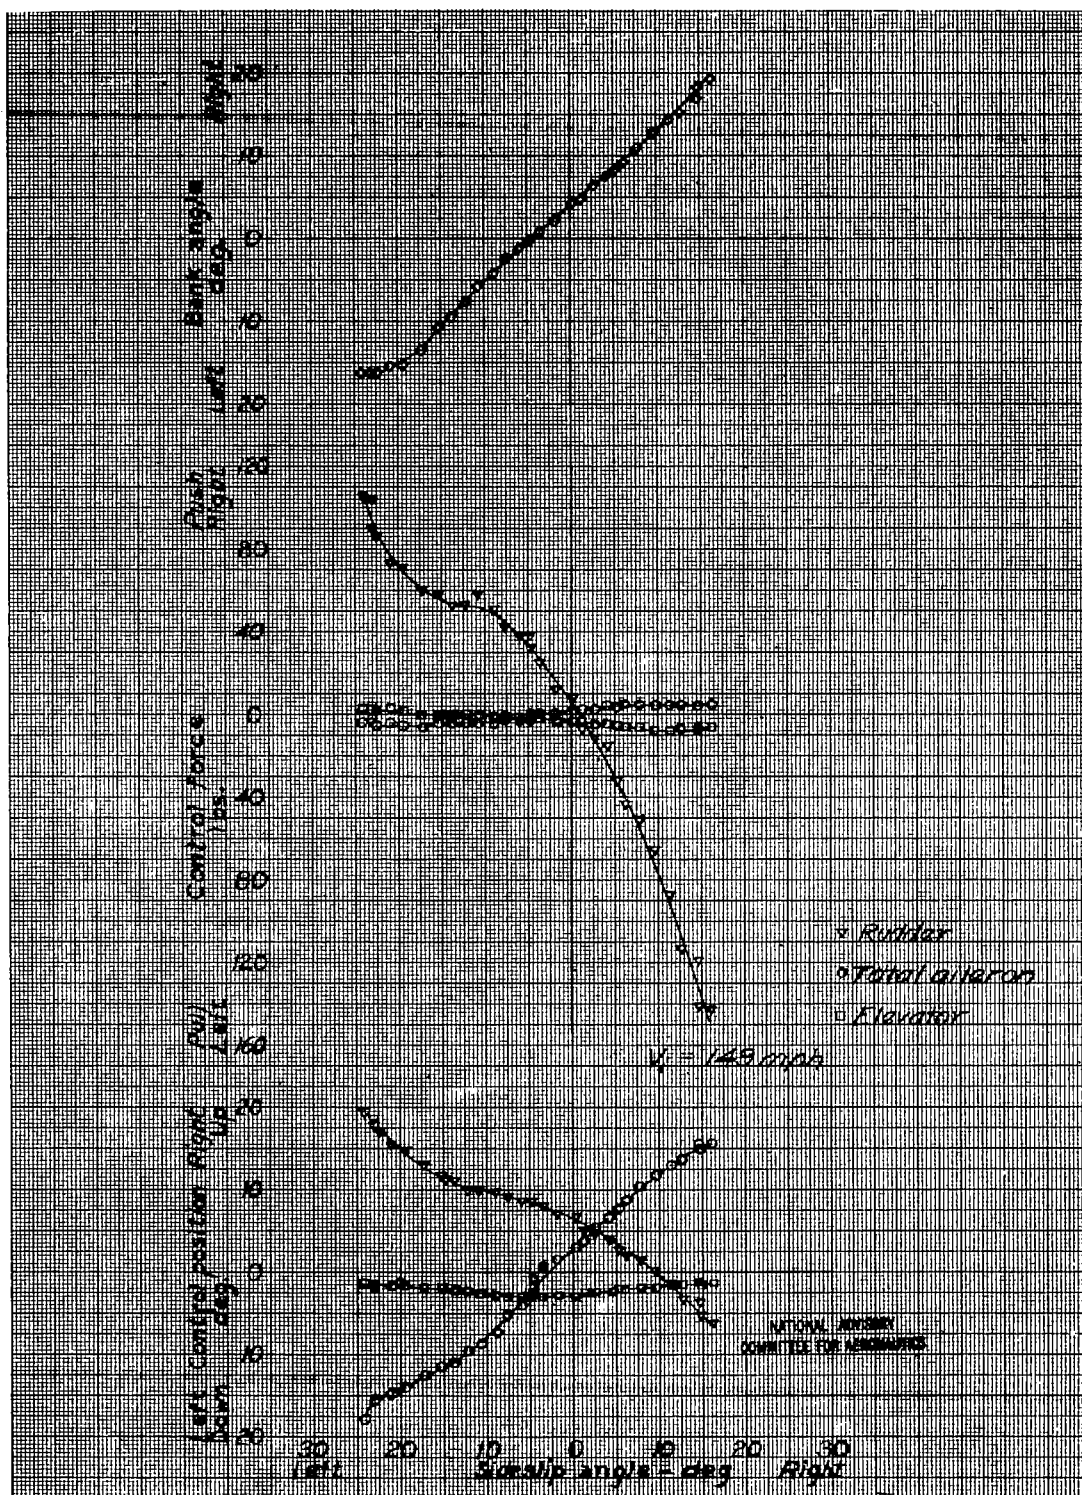
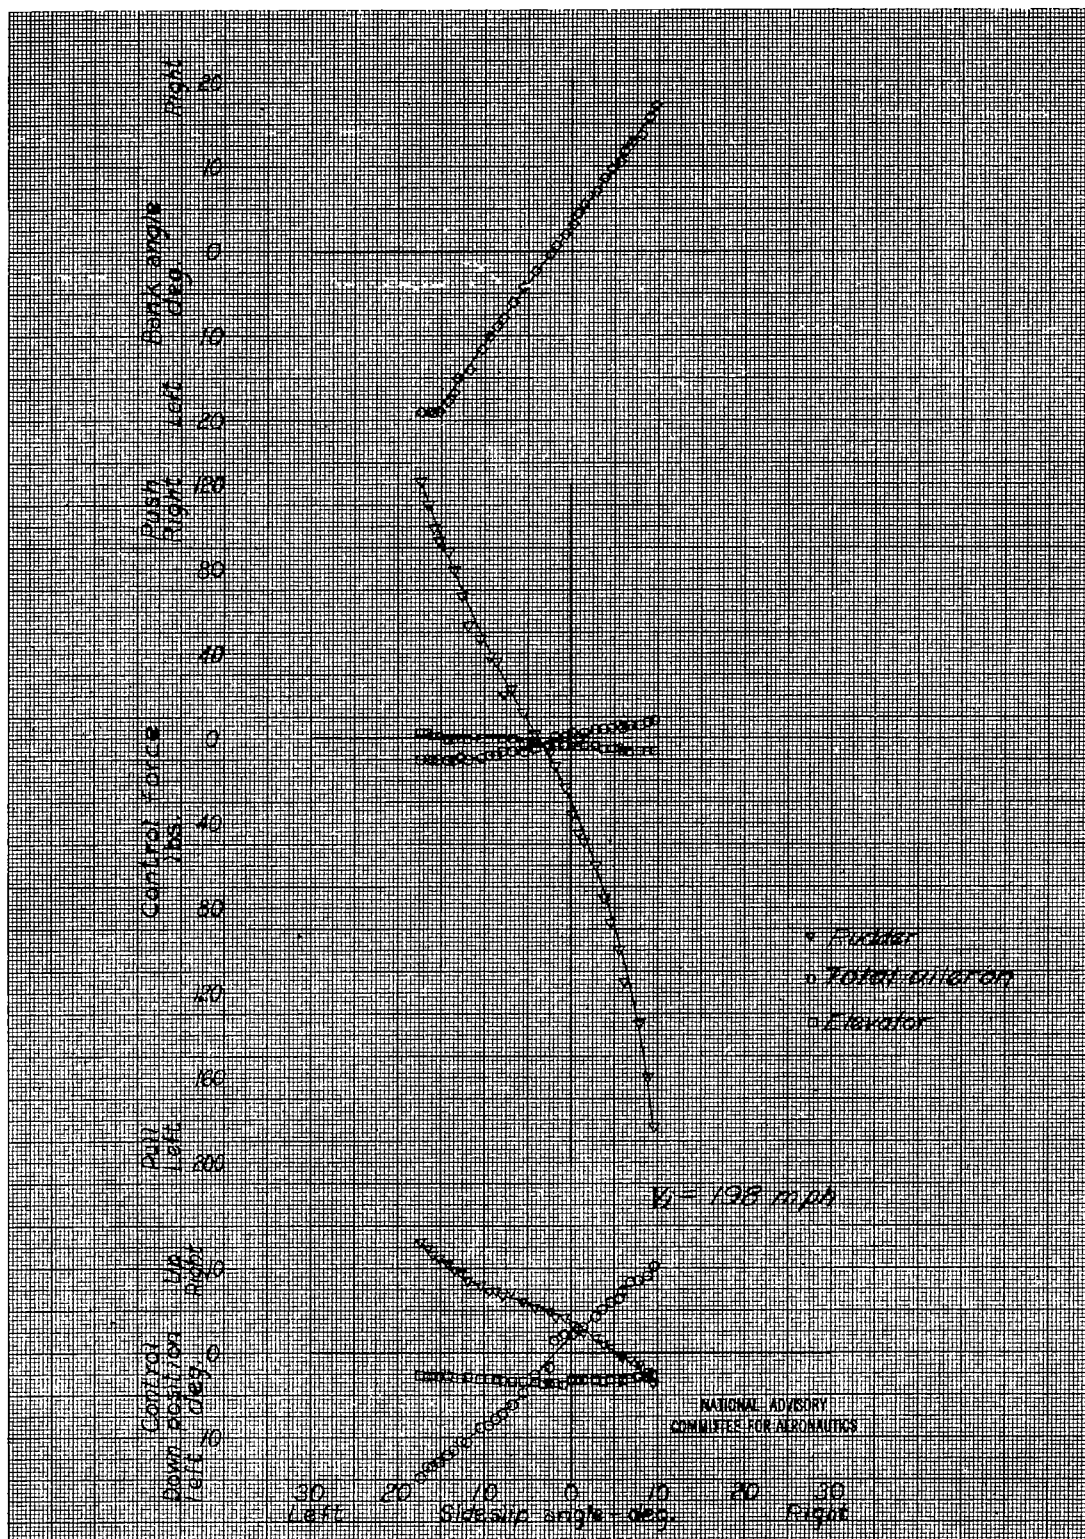
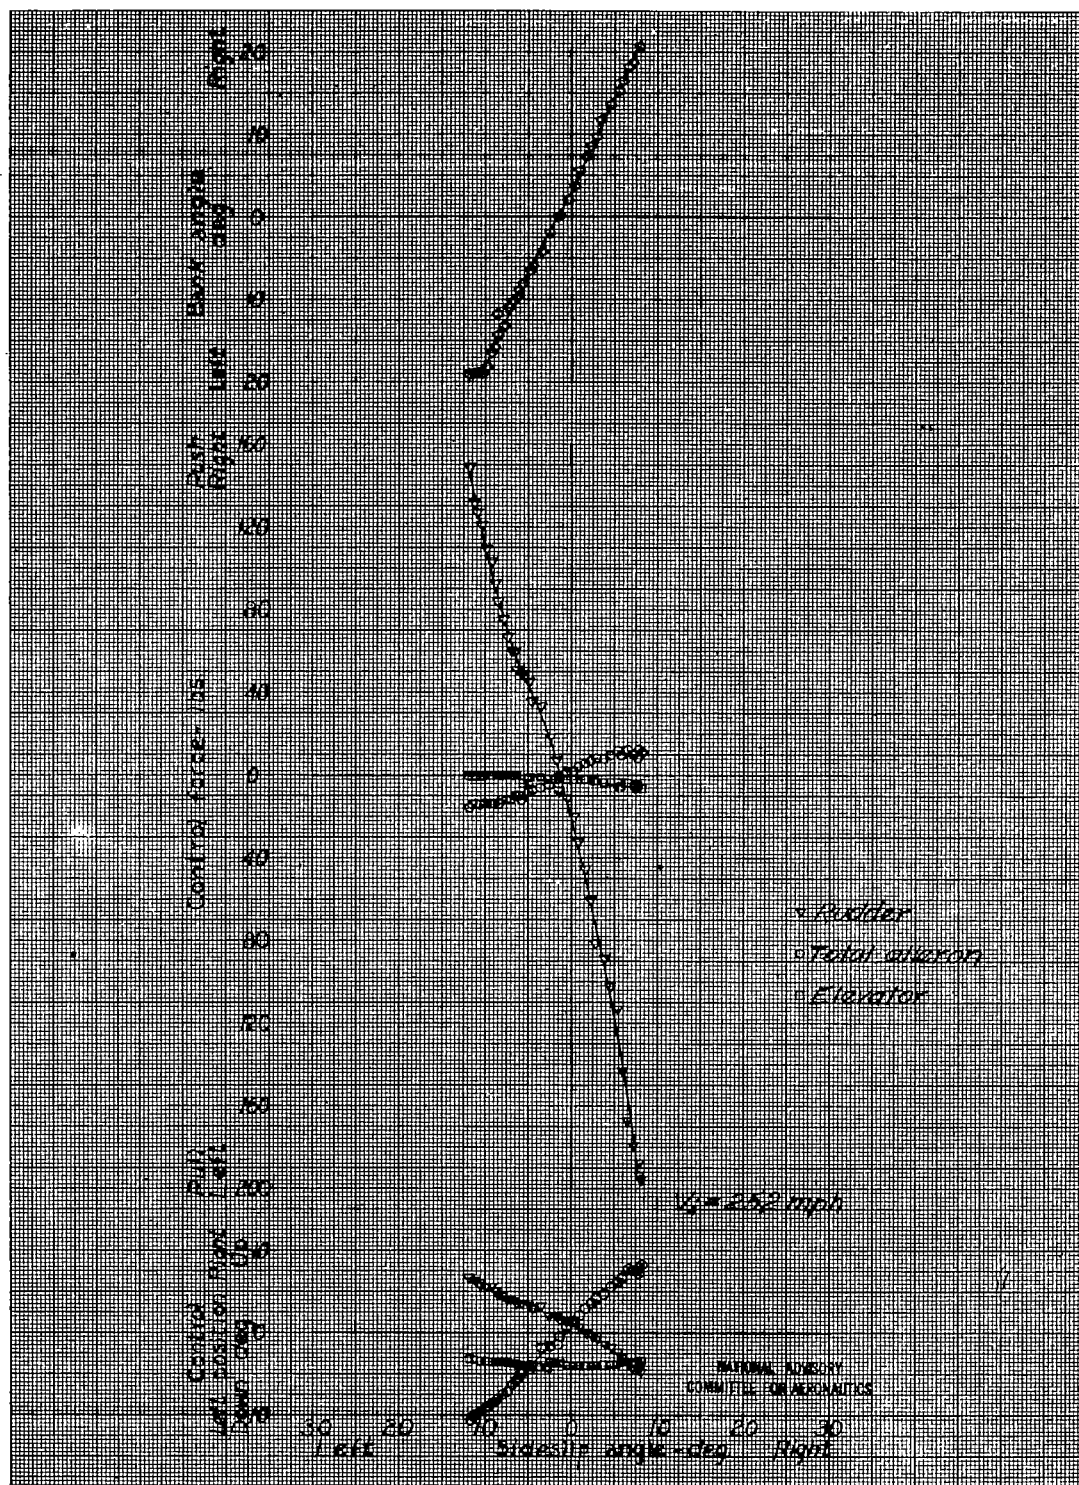
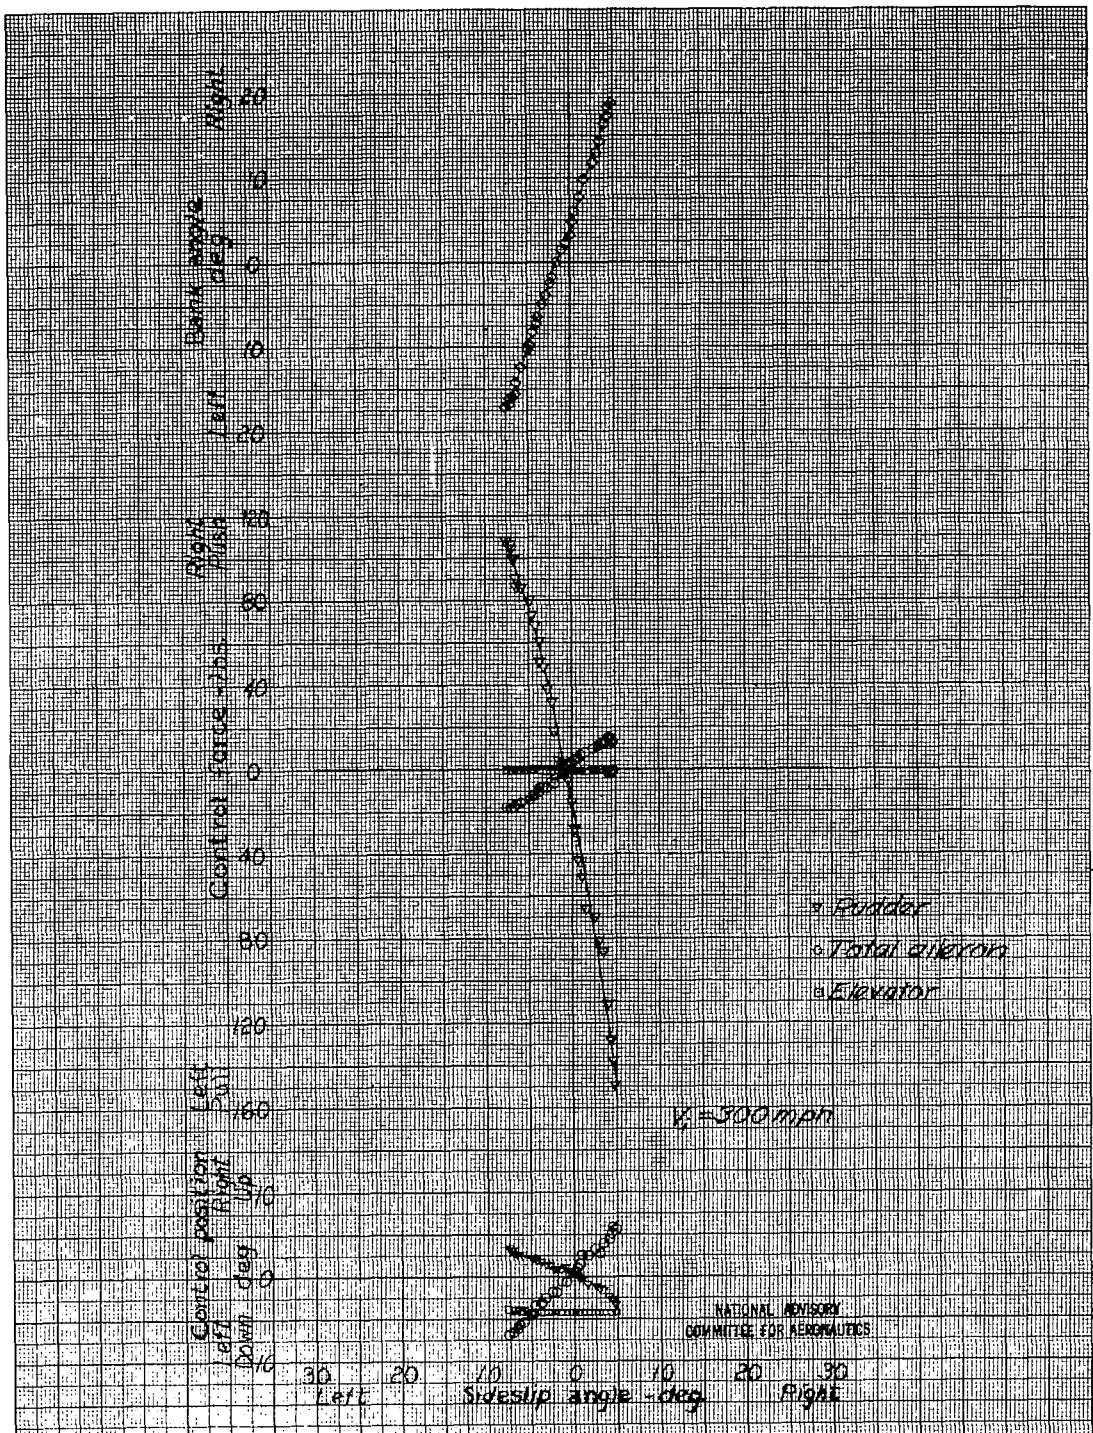
Figure 26. - Steady sideslip characteristics in the climbing condition at 93 miles per hour, F6F-3 airplane.

Figure 27. - Steady sideslip characteristics in the climbing condition at 149 miles per hour, F6F-3 airplane.

Figure 26. - Steady sideslip characteristics in the climbing condition at 198 miles per hour, F6F-3 airplane.

Figure 29. - Steady sideslip characteristics in the climbing condition at 252 miles per hour, F6F-3 airplane.

Figure 30. - Steady sideslip characteristics in the climbing condition at 300 miles per hour, F6F-3 airplane.

4. As shown by figures 16 to 29 right-rudder force was required to hold right-rudder deflections and left-rudder force was required to hold left-rudder deflections.

The variation of cross-wind force with sideslip angle was in the correct direction; that is, right bank accompanied right sideslip and left bank accompanied left sideslip as shown by figures 17 to 30.

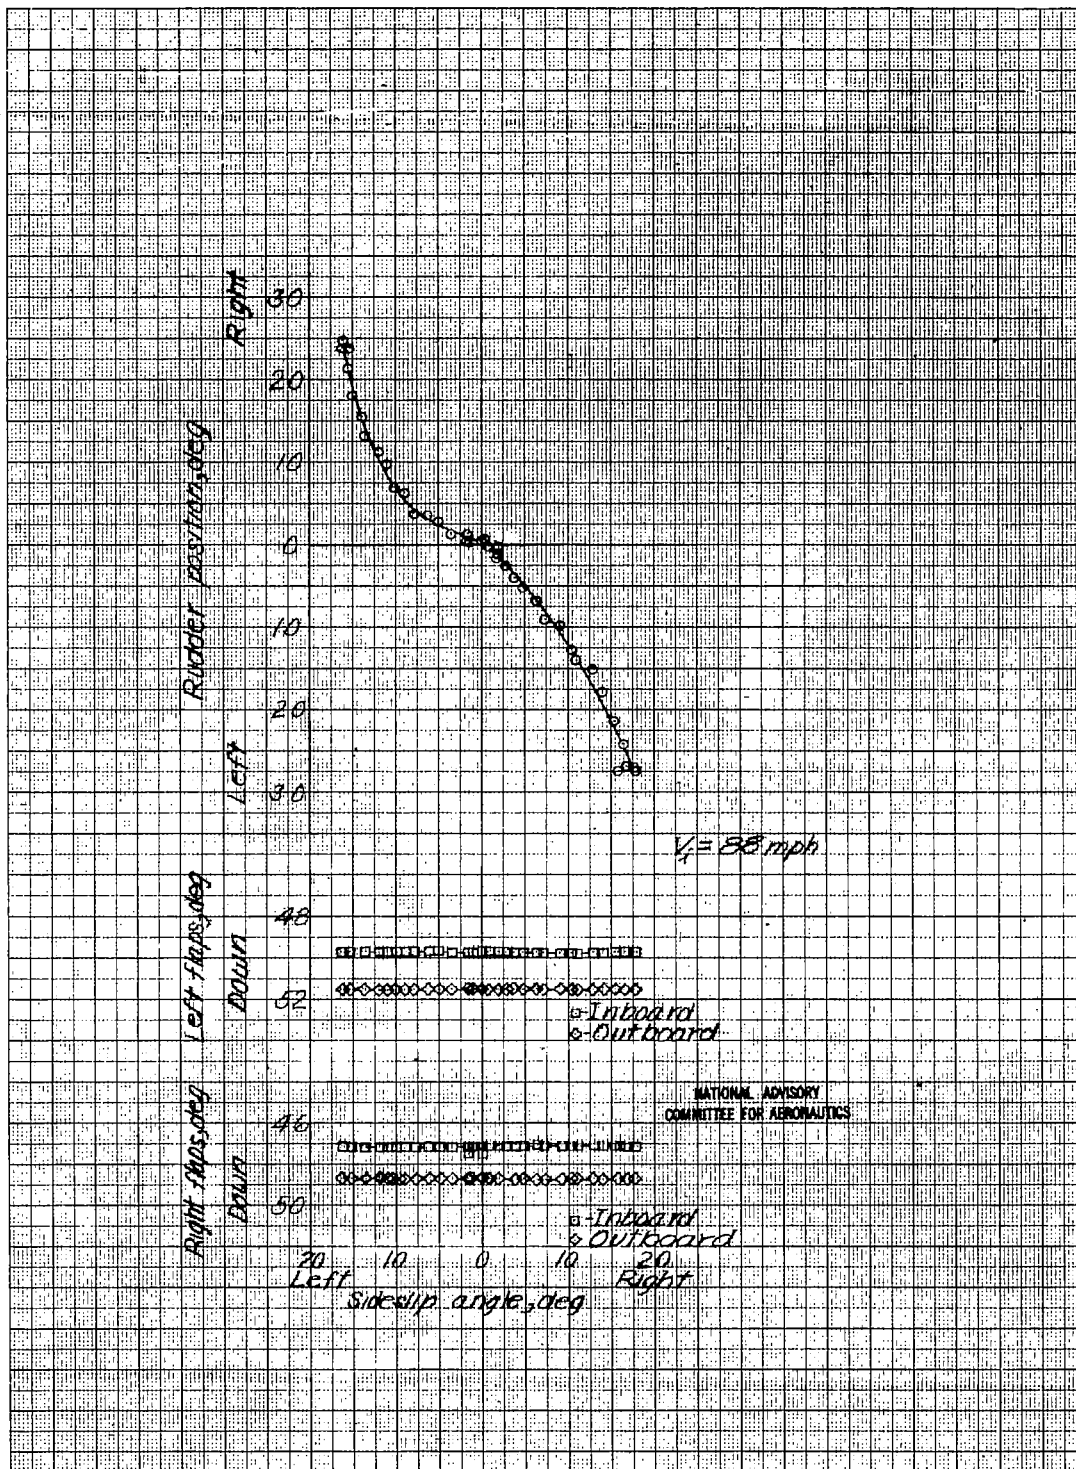
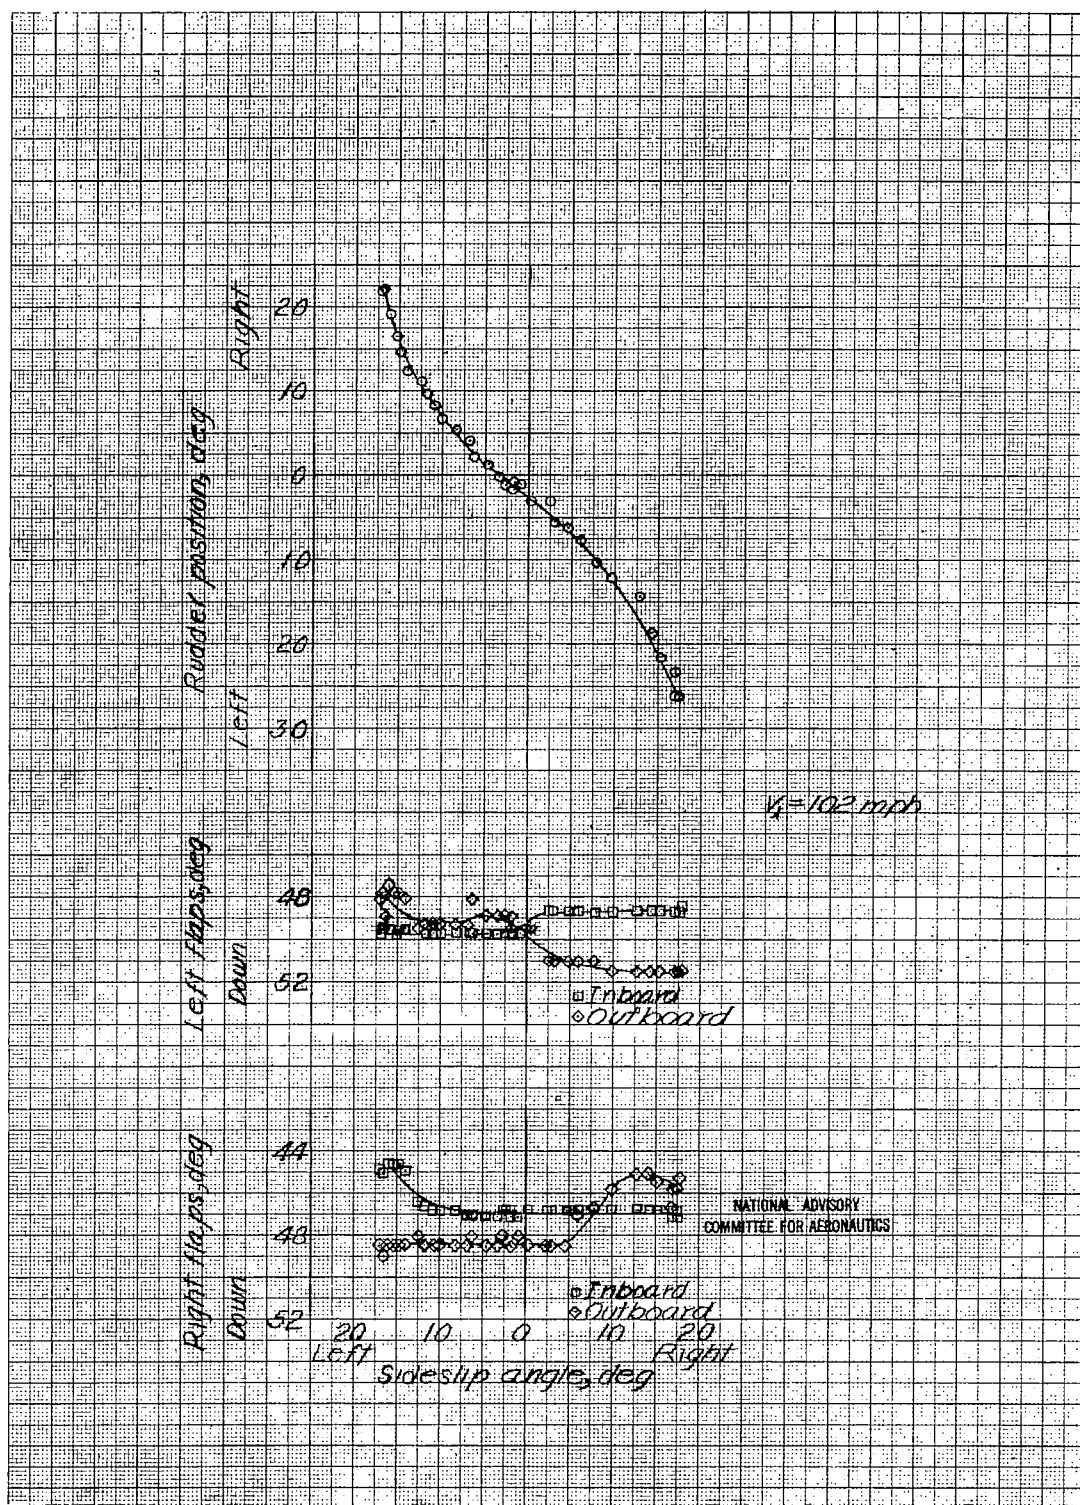
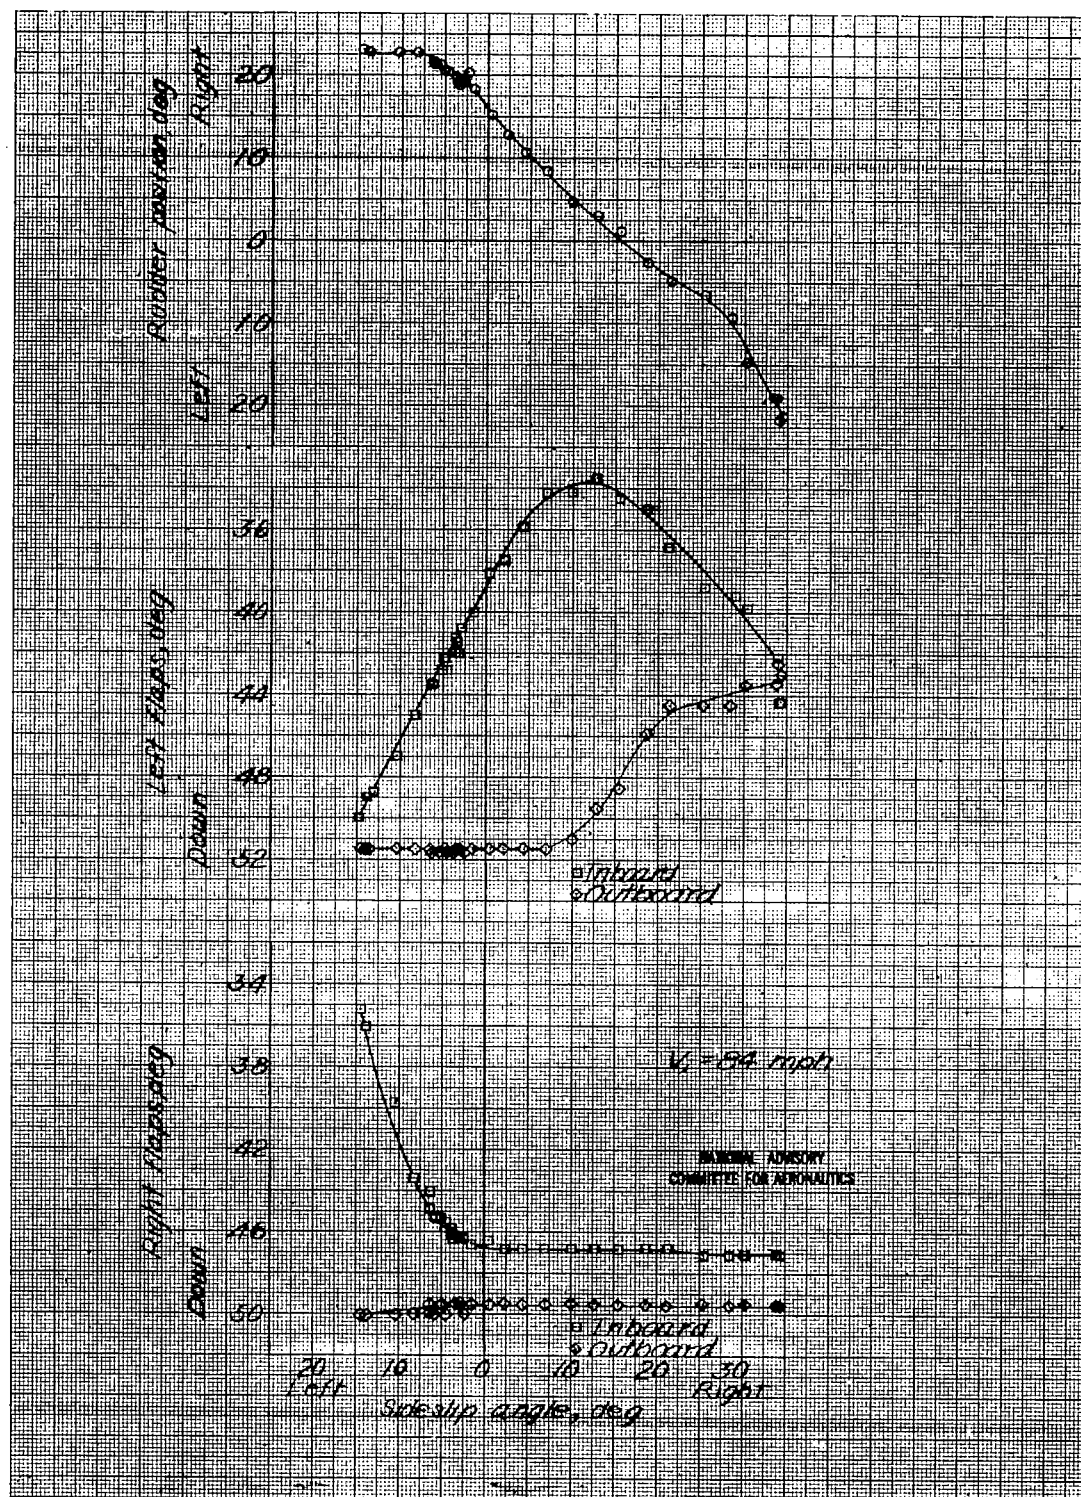
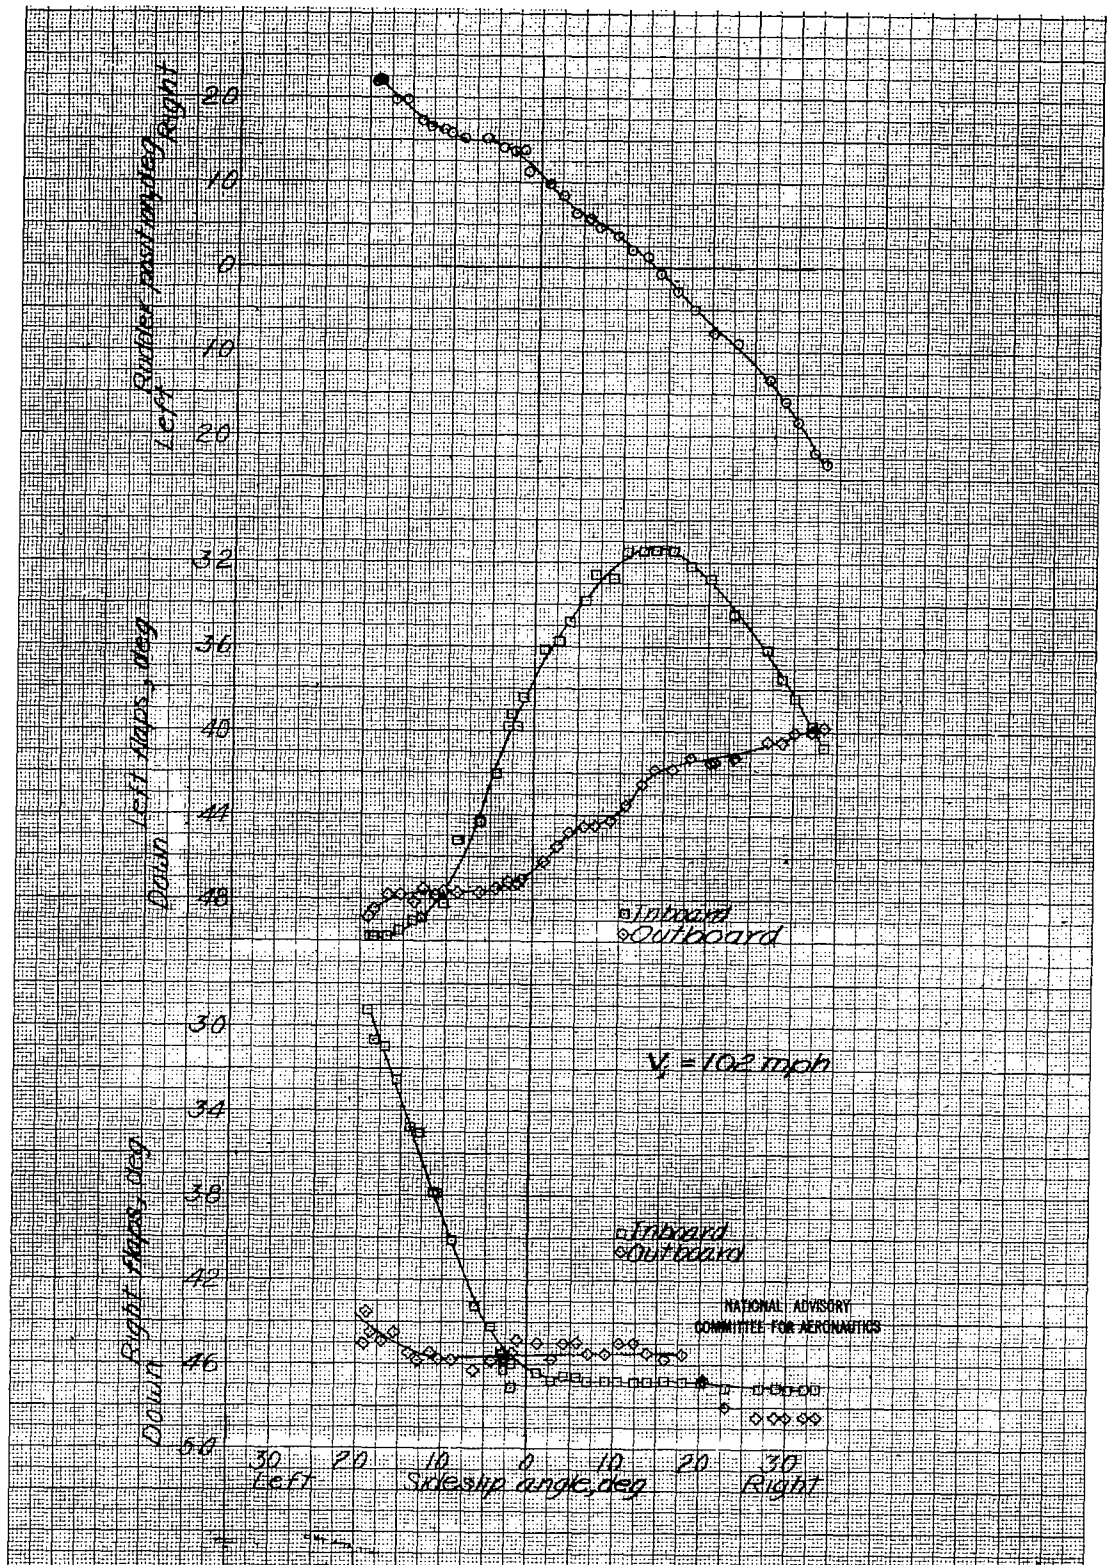
Figure 31. - Flap blow-up characteristics in steady sideslips,
 $V_1 = 88$ miles per hour, landing condition,
 F6F-3 airplane.

Figure 32. - Flap blow-up characteristics in steady sideslips
 $V_1 = 102$ miles per hour, landing condition
 F6F-3 airplane.

Figure 33. - Flap blow-up characteristics in steady sideslips
 $V_1 = 84$ miles per hour, wave-off condition,
 F6F-3 airplane.

Figure 34. - Flap blow-up characteristics in steady sideslips
 $V_1 = 102$ miles per hour, F6F-3 airplane.

3. The blow-up characteristics of the landing flaps are such as to cause greater dihedral effect in the wave-off condition than would be obtained if the flaps were held in a fixed full-down position. With flaps that are held rigidly in the down position, dihedral effect is greatly reduced in the wave-off condition because of the additional lift on the trailing wing as the slipstream moves out over the wing with increasing sideslip angle. In the present instance, however, the destabilizing effect is decreased because the flap deflection is reduced by the slipstream over the trailing wing, which decreases the lift on that wing and causes more positive dihedral effect. Unpublished wind-tunnel tests of an F6F-3 model showed that in the wave-off condition at a lift coefficient of 1.46, which corresponds to a speed of approximately 90 miles per hour, the effective

dihedral with the flaps held fixed was 2.6° , while with the flap deflection varying with sideslip angle in the same manner as in the flight tests, the effective dihedral was 3.5° .

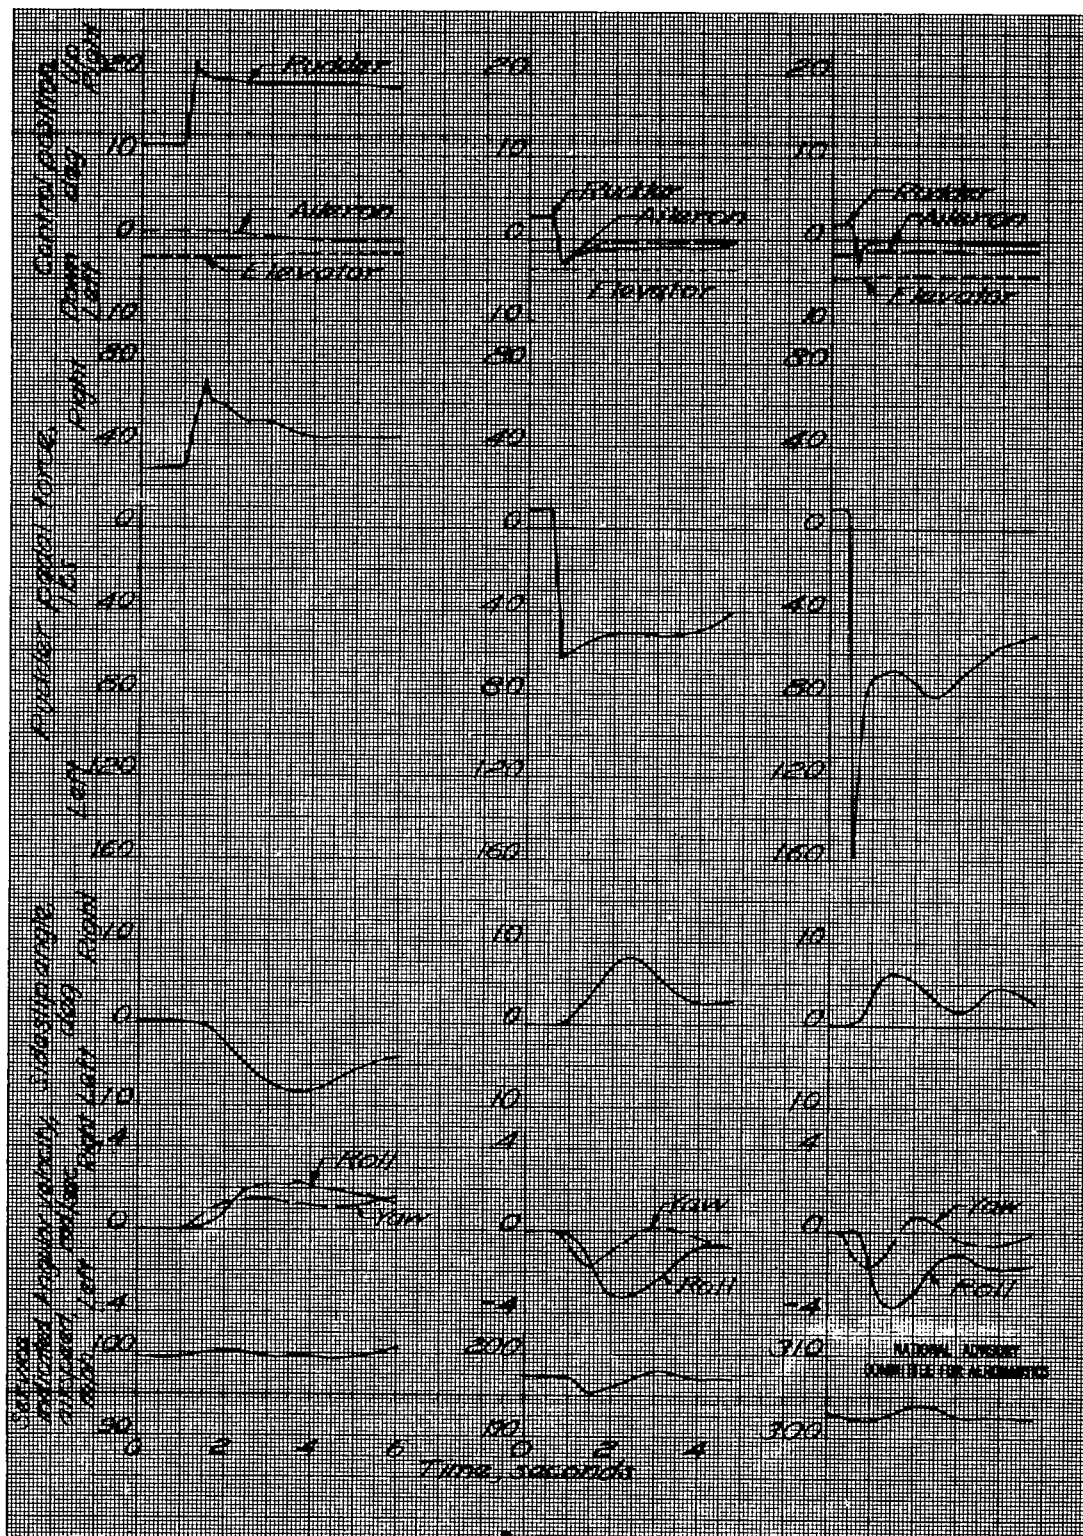
Figure 35. - Typical time histories of abrupt rudder kicks, clean condition, power for level flight, F6F-3 airplane.

The rolling moment due to sideslip was measured in gradually increasing sideslips which were made by slowly deflecting the rudder using the ailerons and elevators to maintain straight flight. A measure of the dihedral effect was obtained from the variation of total aileron angle with sideslip angle. Sideslips were made at various speeds in the landing, wave-off, gliding, and climbing conditions. The data are presented in figures 17 to 30. In these figures rudder, elevator, and aileron forces and deflections and the angle of bank are plotted as functions of sideslip angle. Figures 17 and 18 pertain to the landing condition and data for the wave-off condition are presented in figures 19 and 20. Data for the gliding and climbing condition are shown in figures 21 through 25 and figures 26 through 30, respectively. Additional sideslips were made at a later date in the landing and wave-off condition with control-position recorders installed to measure the landing flap blow-up characteristics. The flaps of the F6F-3 are in four segments which are spring-loaded and blow up independently of each other under aerodynamic loads. A detailed description of this flap arrangement is given in reference 1. During the aforementioned tests the airplane was equipped with an experimental spring tab rudder. The data obtained are shown in figures 31 through 34 where the angle of the four segments of the flaps and the rudder position are plotted as functions of the sideslip angle. Figures 31 and 32 apply to the landing condition and figures 33 and 34 show data for the wave-off condition. Another measure of the dihedral effect was obtained from rudder kicks in which the pilot deflected and held the rudder at a given position, holding the ailerons fixed at trim. Typical time histories of this maneuver are shown

in figure 35. The data obtained were used to determine the variation of maximum yawing and rolling velocity and maximum change in sideslip angle with change in rudder angle. These results are shown in figure 36.
